TOWN OF BARRINGTON

ATHLETIC FIELDS CONDITION AND NEEDS ANALYSIS

Date: September, 2023

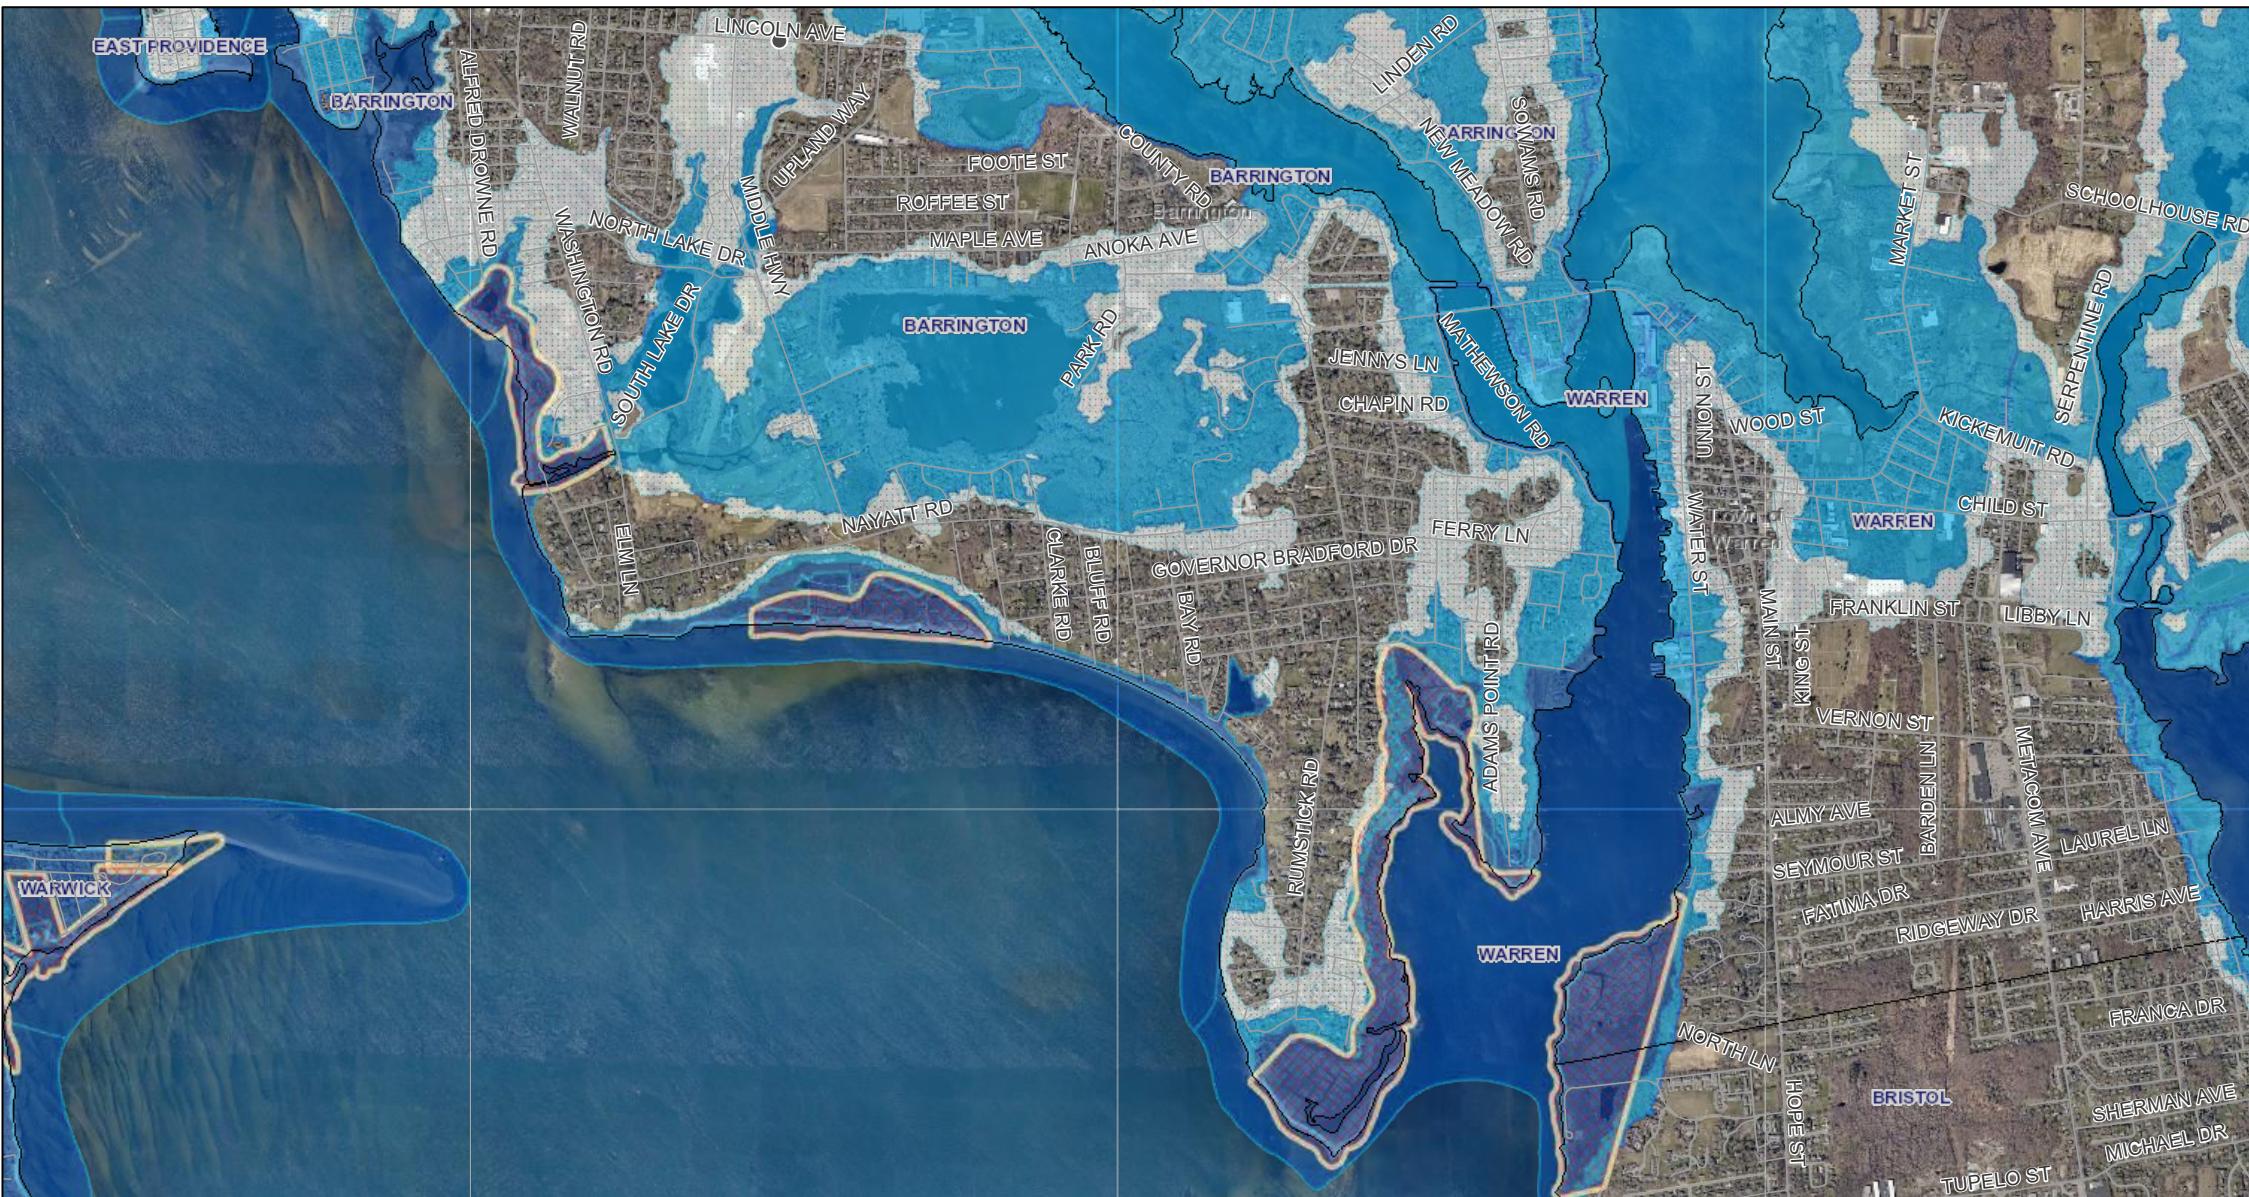
TOWN OF BARRINGTON FLOOD ZONE

The Town of Barrington is a Rhode Island coastal community and with many coastal communities comes with the potential for flooding. As part of this master plan, consideration for flooding needs to be considered as part of the assessment. Flooding can present potential risk to athletic assesssts.

As an example the entire high school site falls into an AE Zone with 1% of annual flooding. An AE Flood Zone demarcates an area susceptible to moderate to high flood risk, as classified by FEMA. These zones indicate the likelihood of inundation during specific weather events or due to nearby water bodies, such as rivers or heavy precipitation. Properties situated within AE Flood Zones typically necessitate adherence to stringent building codes and the procurement of flood insurance to mitigate potential damages stemming from flooding occurrences.

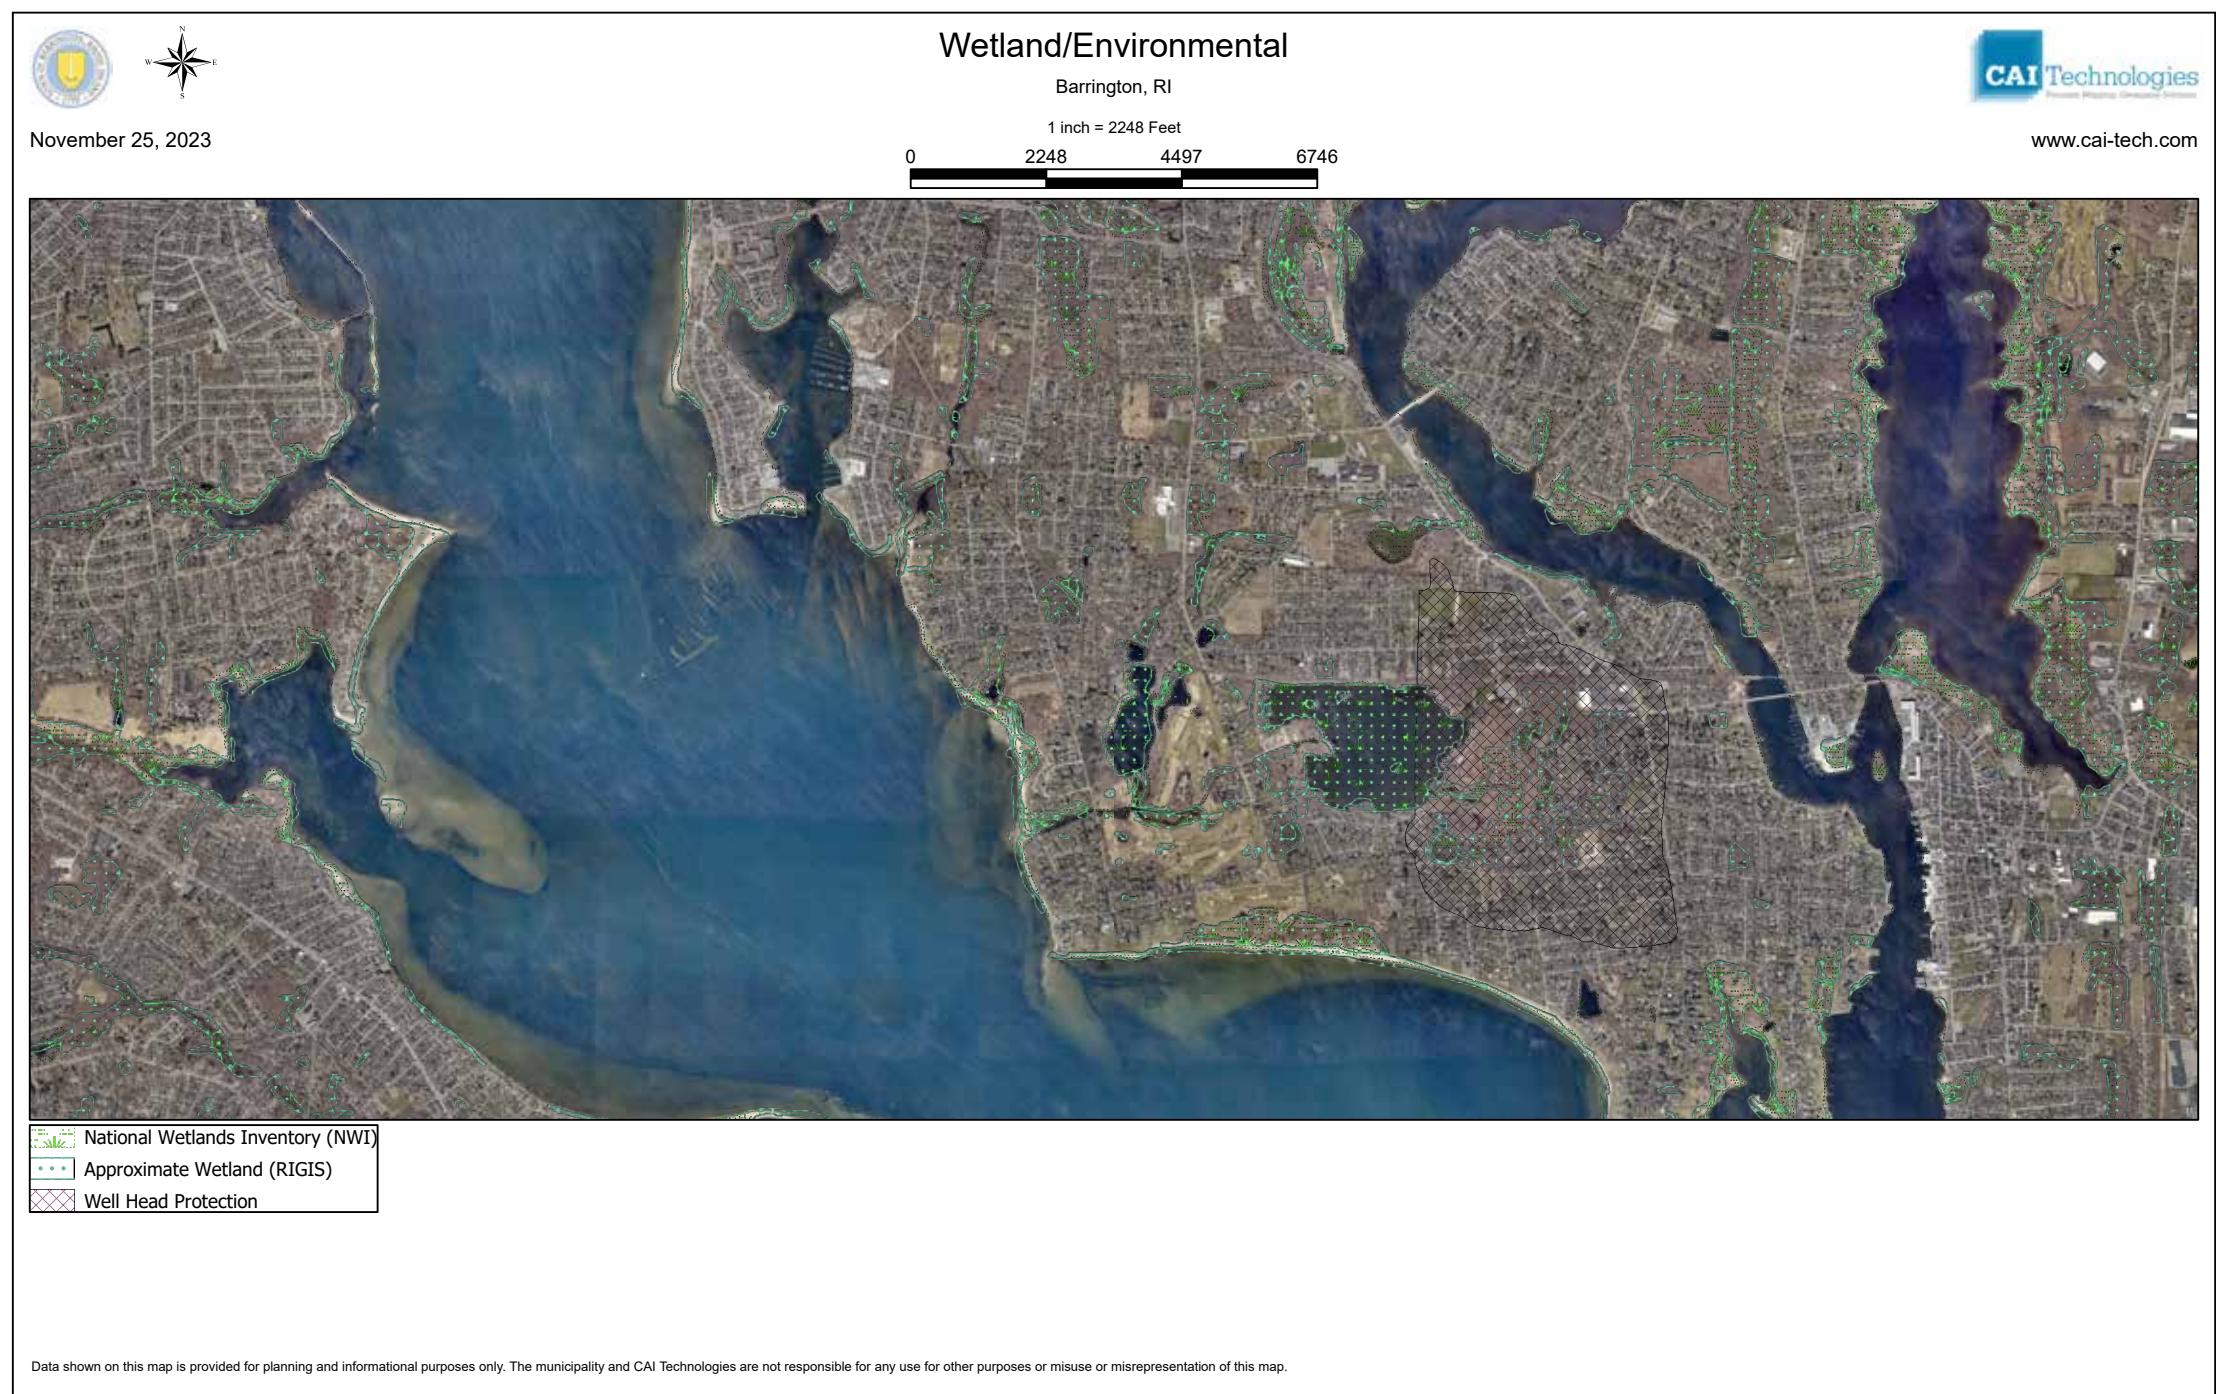
The Town of Barrington is a Rhode Island coastal community and with many coastal communities comes the potential for upland streams and wetlands. These areas are both federally and state protected areas for the betterment of the community at large. As part of this master plan, consideration for wetlands and their setbacks to be considered as part of the assessment. Wetlands and Environmental conditions can have an impact on landuse and athletic fields can impact those environmental bodies so, planning should be carefully considered for potential risk.

As an example, both the Nyatt School Fields and the Chianese Middle and Lower Field fall in a well head protection area. A wellhead protection area (WHPA) refers to the designated area surrounding a drinking water well or water supply source that requires safeguarding from potential sources of contamination. It delineates the zone where activities and land use could significantly impact the quality and integrity of the groundwater feeding into the well. The primary goal of establishing a WHPA is to prevent, manage, and mitigate any potential risks posed by pollutants, chemicals, or other contaminants that could infiltrate the groundwater and compromise its suitability for human consumption. Consideration of maintenance and surfaces choices should be carefully planned.

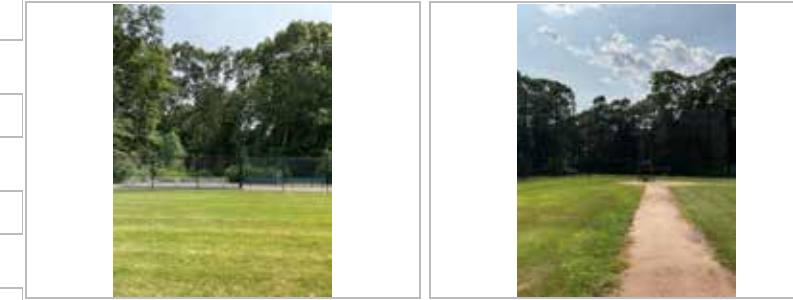
Abutters Photos

View shed is similar to that of north and south multipurpose fields. Little to no noise as baseball field is furthest from road. Only minimal noise from adjacent residential neighborhood. Condition of planting is relatively healthy with majority of planting being large scale vegetation and surrounding vegetation closest to field are small woody trees/shrubs.

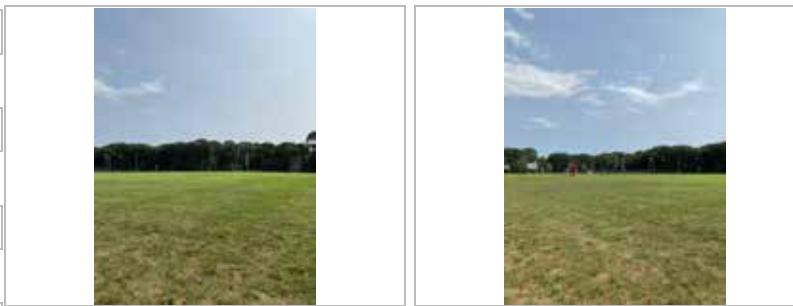
Abutters Photos

All are similar to field north however field south is closer to road so noise level is slightly louder than field north. There is not buffer plantings or plantings in general since field south is between the outfield of baseball and the parking lot on the west side of the middle school.

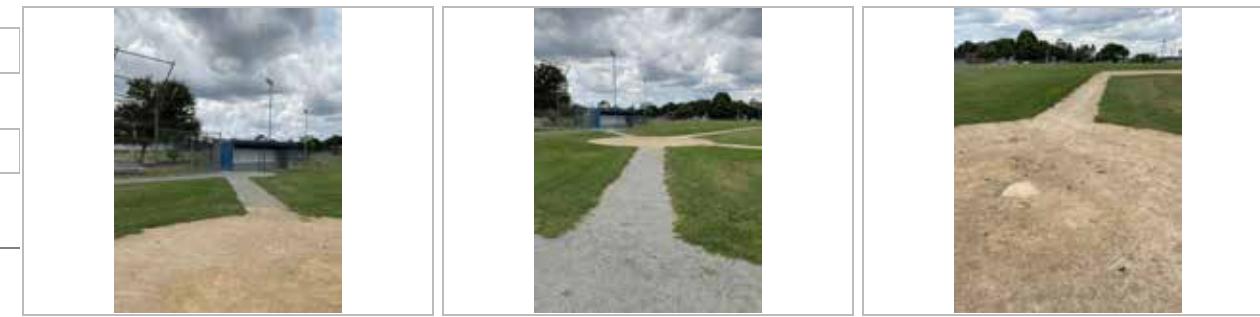
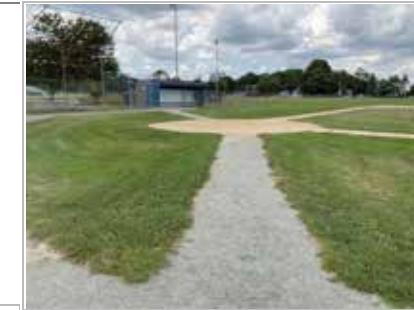
Photos Buffers/Plantings

View sheds: clear view shed of field into outfield and County Rd. JV field and multipurpose fields are visible from baseball diamond. Noise buffers: little to minimal noise buffers. Field is open and clear of any significant vegetation Condition of planting: turf seems to be in relatively decent condition. Some patching in high traffic areas, build up of dead grass. Field including adjacent field hockey and soccer field are covered in goose poop. From entrance of dugout to field, there is a change in material (stone dust to dirt). Lots of weeds and scattered grass tufts infect the infield dirt areas.

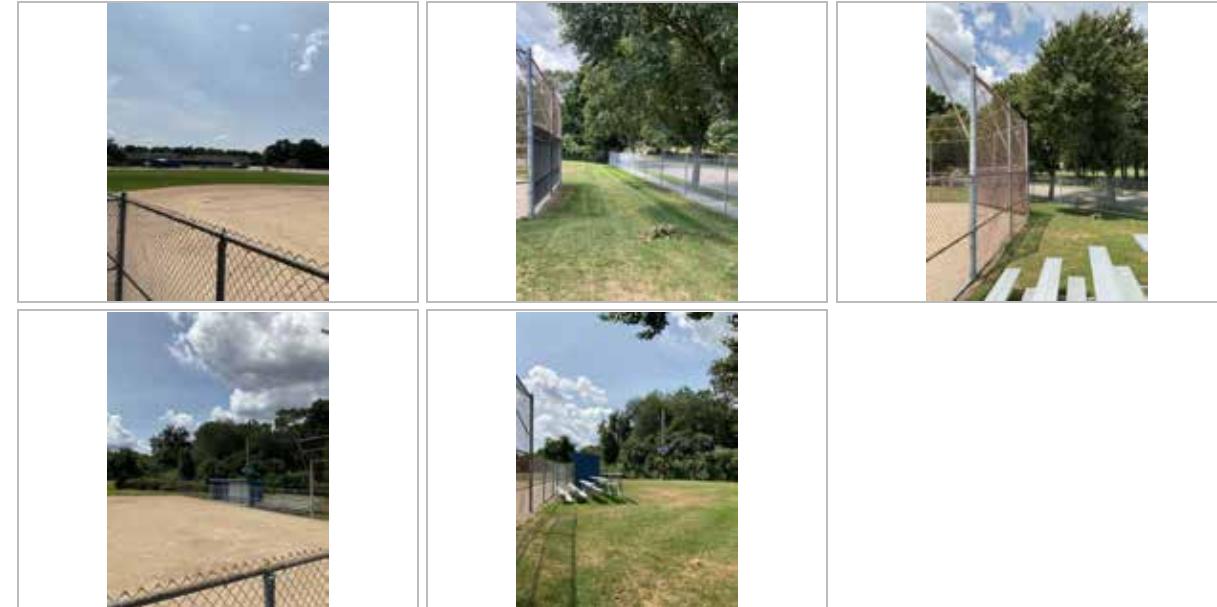
Abutters Photos

View Sheds: Large view shed from home plate to outfield. Able to see into high school parking lot (west side of school). View is open from both sets of bleachers onto field. Noise buffers: limited planting along County Rd is not significant enough to form a noise buffer. The large vegetation grouping along first base line may act as a noise barrier for oncoming traffic down Count Rd towards the water. Condition of planting:

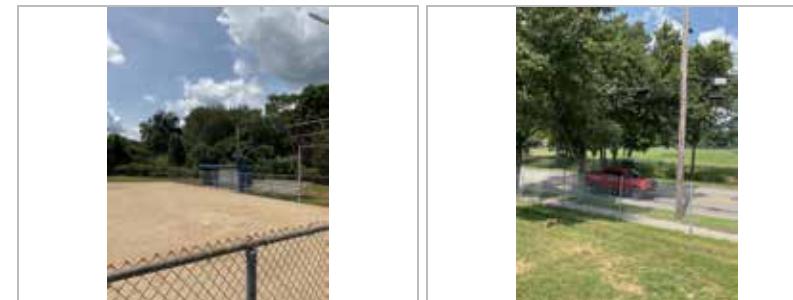
Photos Buffers/Plantings

Large vegetation buffer along first base line may impact field operations.

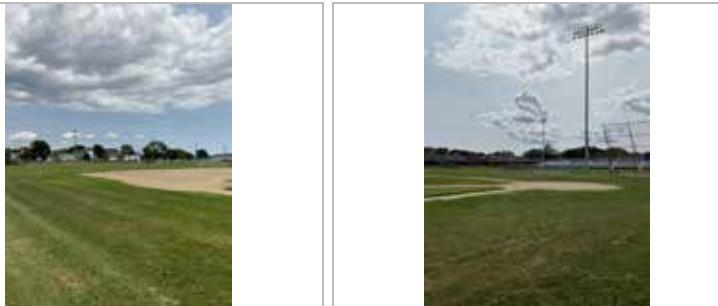
Abutters Photos

View sheds remain open and noise buffers remain limited. Condition of planting along street seems relatively healthy. Turf includes weeds and thatch build up. JV field has less random weed pockets in infield than varsity field does.

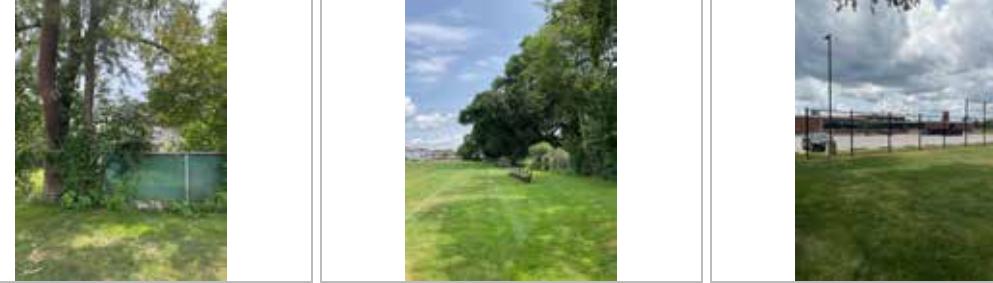
Abutters Photos

View sheds: view shed into field and onto County Rd is clear. There is also a clear view shed of the parking lot from field as well as clear views of the varsity and JV baseball fields, County Rd and the built environment on this road. There IS NOT a clear view however of the water (Barrington River) as the majority of the vegetation and built environment on County Rd blocks this view.

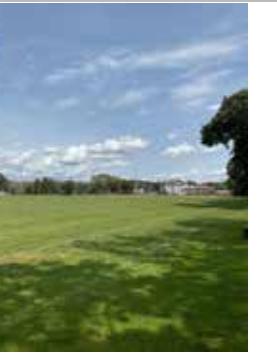
Patching of dead grass/uneven surfacing The field drops off beyond the east end of the field ADA Access

Extending the field to accommodate rotation of goal mouths. Maintenance Improvements

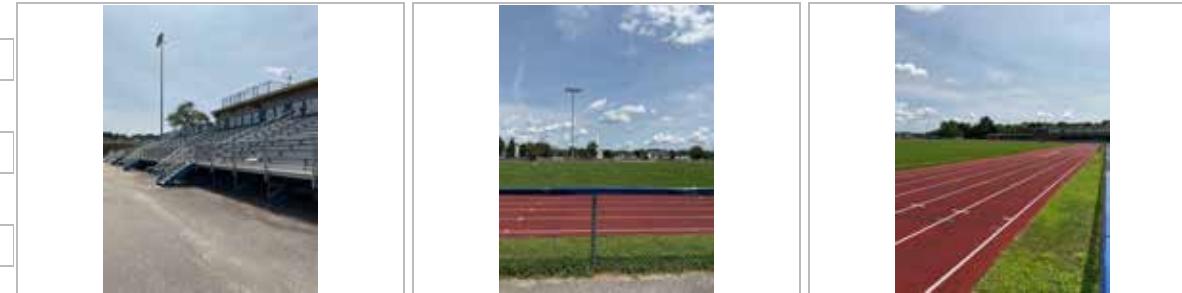
Abutters Photos

View sheds: significant view sheds include unblocked views of the entire field including the track, JV and V baseball, V. softball, the school and traffic on County and Federal Rd. Noise buffers: Large stadium bleachers help create a noise buffer. However, minimal planting allows for noise from County and Federal Rd to enter the site. Condition of planting: Turf field seems to be in pretty good condition. Minimal tufting of turf has occurred. Patching of dead grass seen closest to outside of field boundaries as well as in high trafficked areas on field.

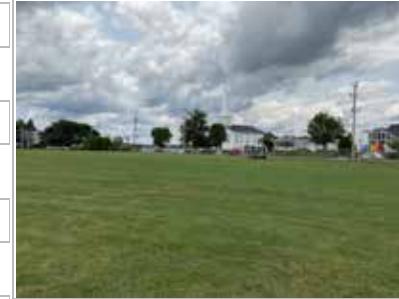
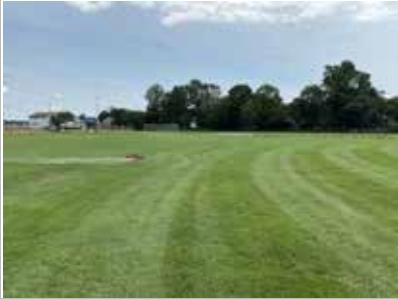
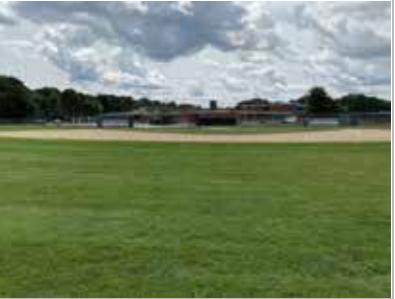
Abutters Photos

Like most other fields on site, view sheds remain open and noise buffers are minimal. Condition of planting is relatively in decent condition with minimal street trees along outside of fenced field.

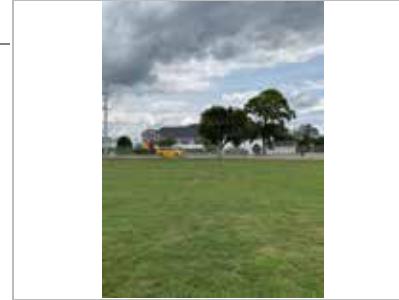
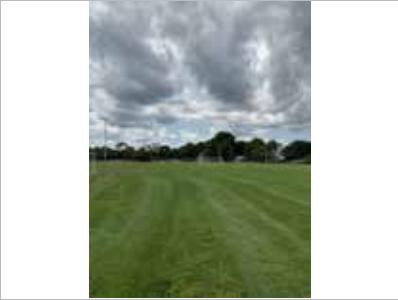
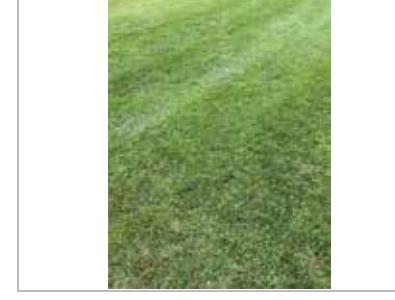
Photos Buffers/Plantings

Proximity to significant waterway limits the ability to do a turf field. This field as well as both baseball fields and adjacent multipurpose field show signs of goose activity. Possible interference here.

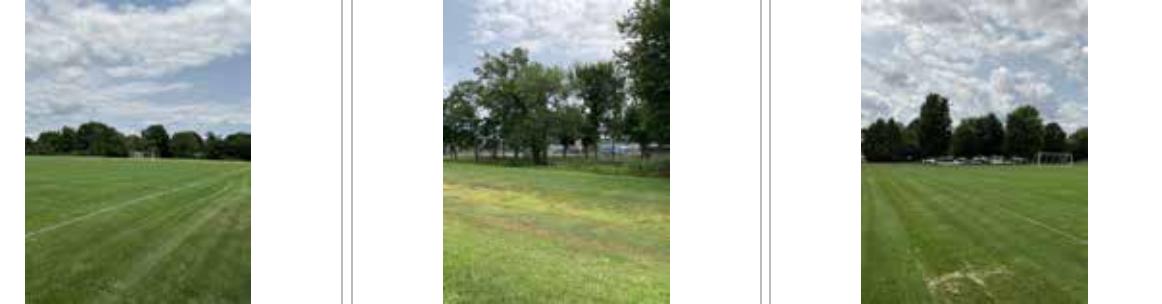
Abutters Photos

View sheds: fields surrounded by large vegetation. Clear view shed on St Andrews tennis. Other adjacent properties such as residential units and street are blocked by vegetation. Noise buffer: trees along street provide some noise barrier yet does not block out noise completely. When on field, you can hear traffic on Federal and County Rd although it is not particularly loud.

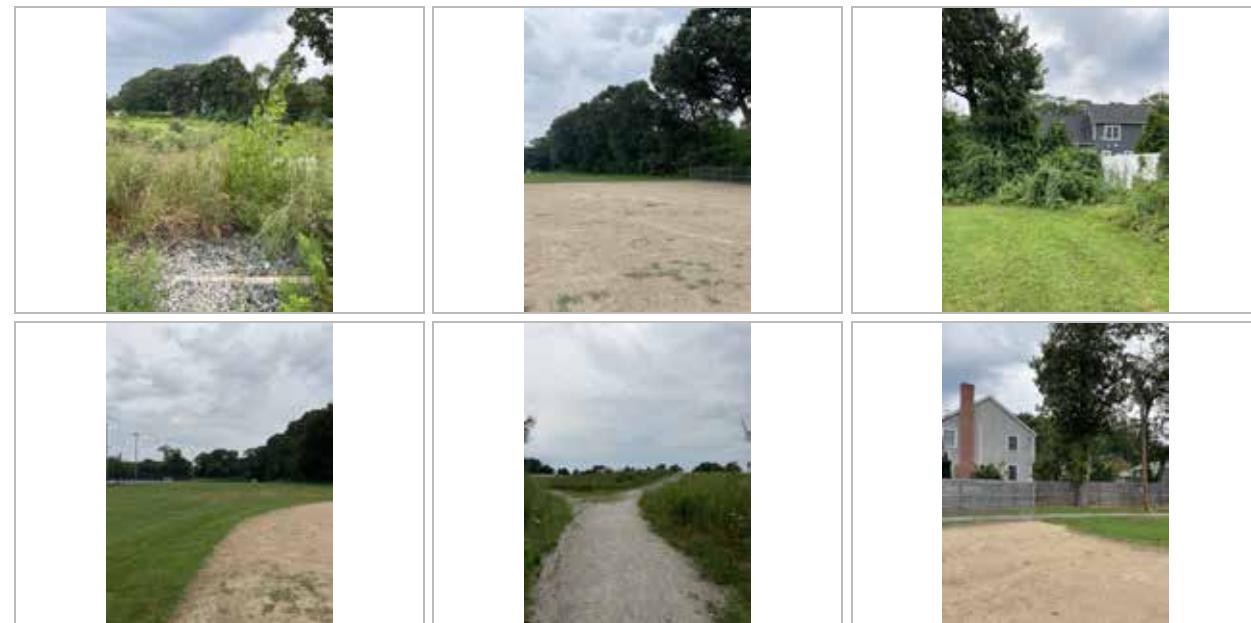
Abutters Photos

View sheds include multipurpose field, tennis courts and front of high school (Lincoln Ave). Large vegetation allows for noise buffer from residential properties and location of field allows for noise from Lincoln to be mitigated (still present but not as loud as it would be closer to road). Condition of planting is fair with some dead grass along fence lines. However for the most part, vegetation is in good condition.

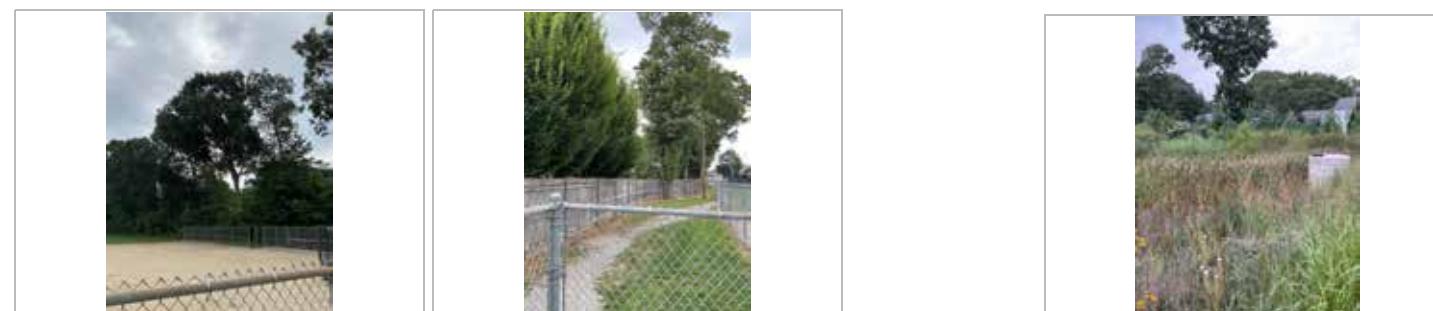
Photos Buffers/Plantings

Possibly the man made wetland adjacent to field. Possible environment features may also include what is behind the field (south east of home plate)

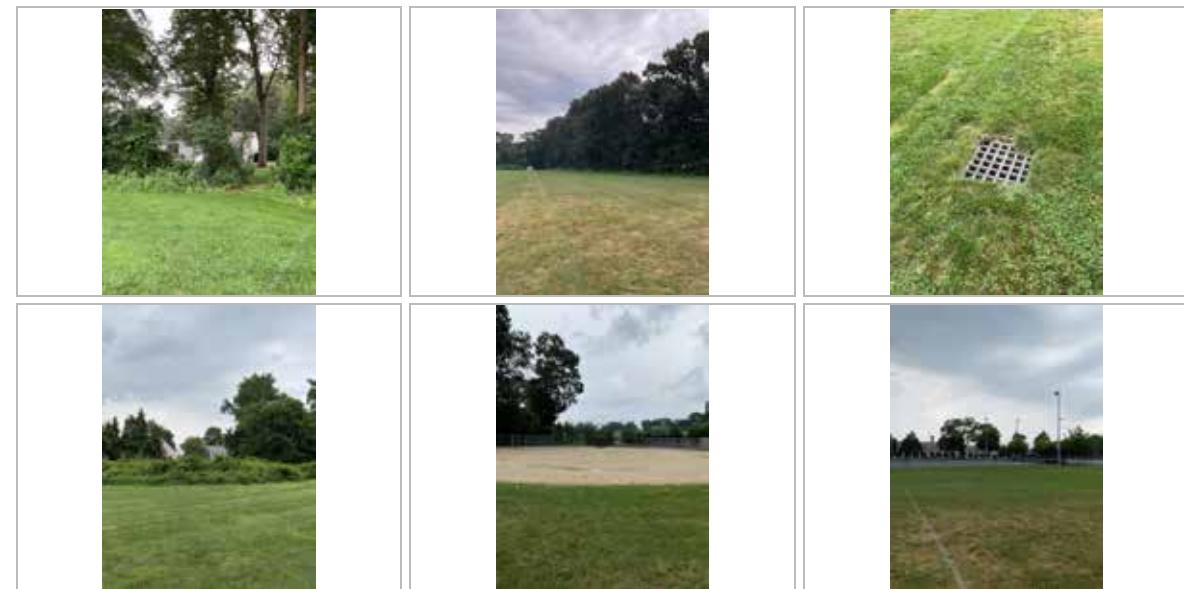
Abutters Photos

View sheds are similar to adjacent softball field having full view of tennis courts and partial view of high school across the street. Noise buffers are also similar. Low noise from tennis courts and Lincoln Ave. Possible noise from adjacent residencies. Condition of planting, specifically turf, is lacking. Most of field is dead patched grass as field is assumed to be used year round.

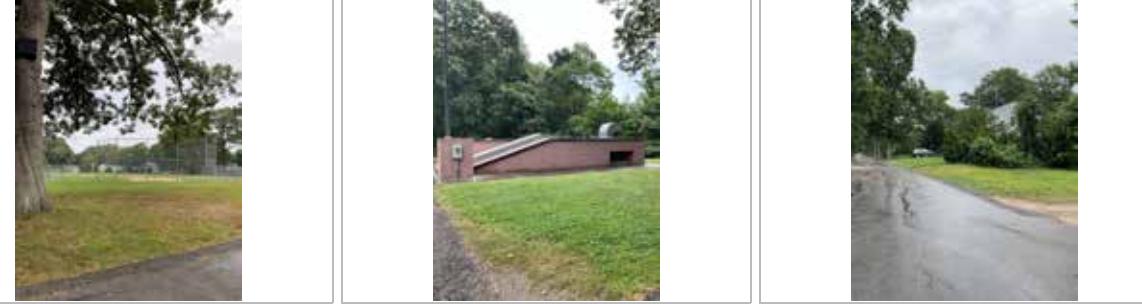
Abutters Photos

View sheds include the multipurpose field adjacent to field as well as from properties of houses on Alden Street. Little to no noise in area since all streets are side streets with only residential units. Condition of planting is in great condition. Small patches of dead grass along fence line and under large oaks lining Alden street.

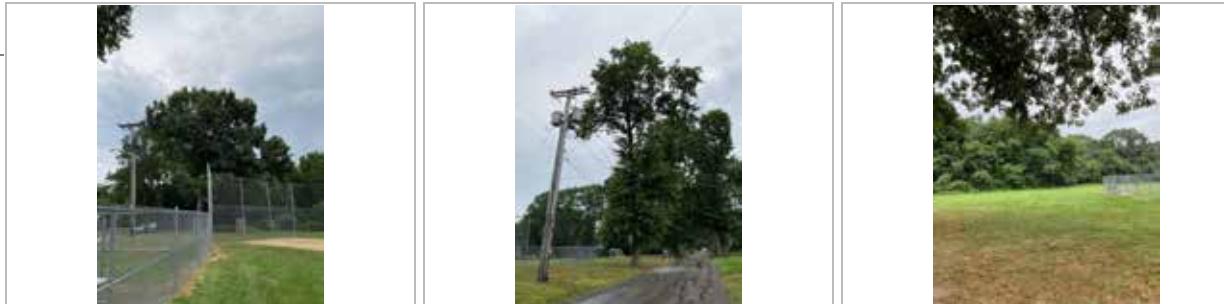
Photos Buffers/Plantings

Potential bat population in the area due to bat box found on large oak behind backstop

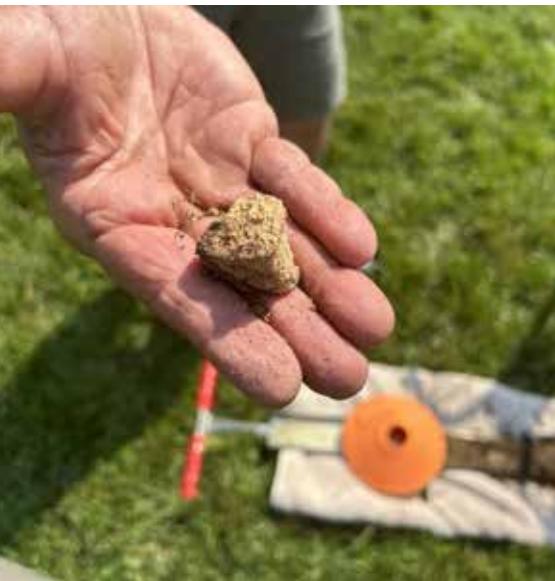
Test point 5 profile showing good root depth and root zone medium depth.

Test point 5 had brick like material near base.

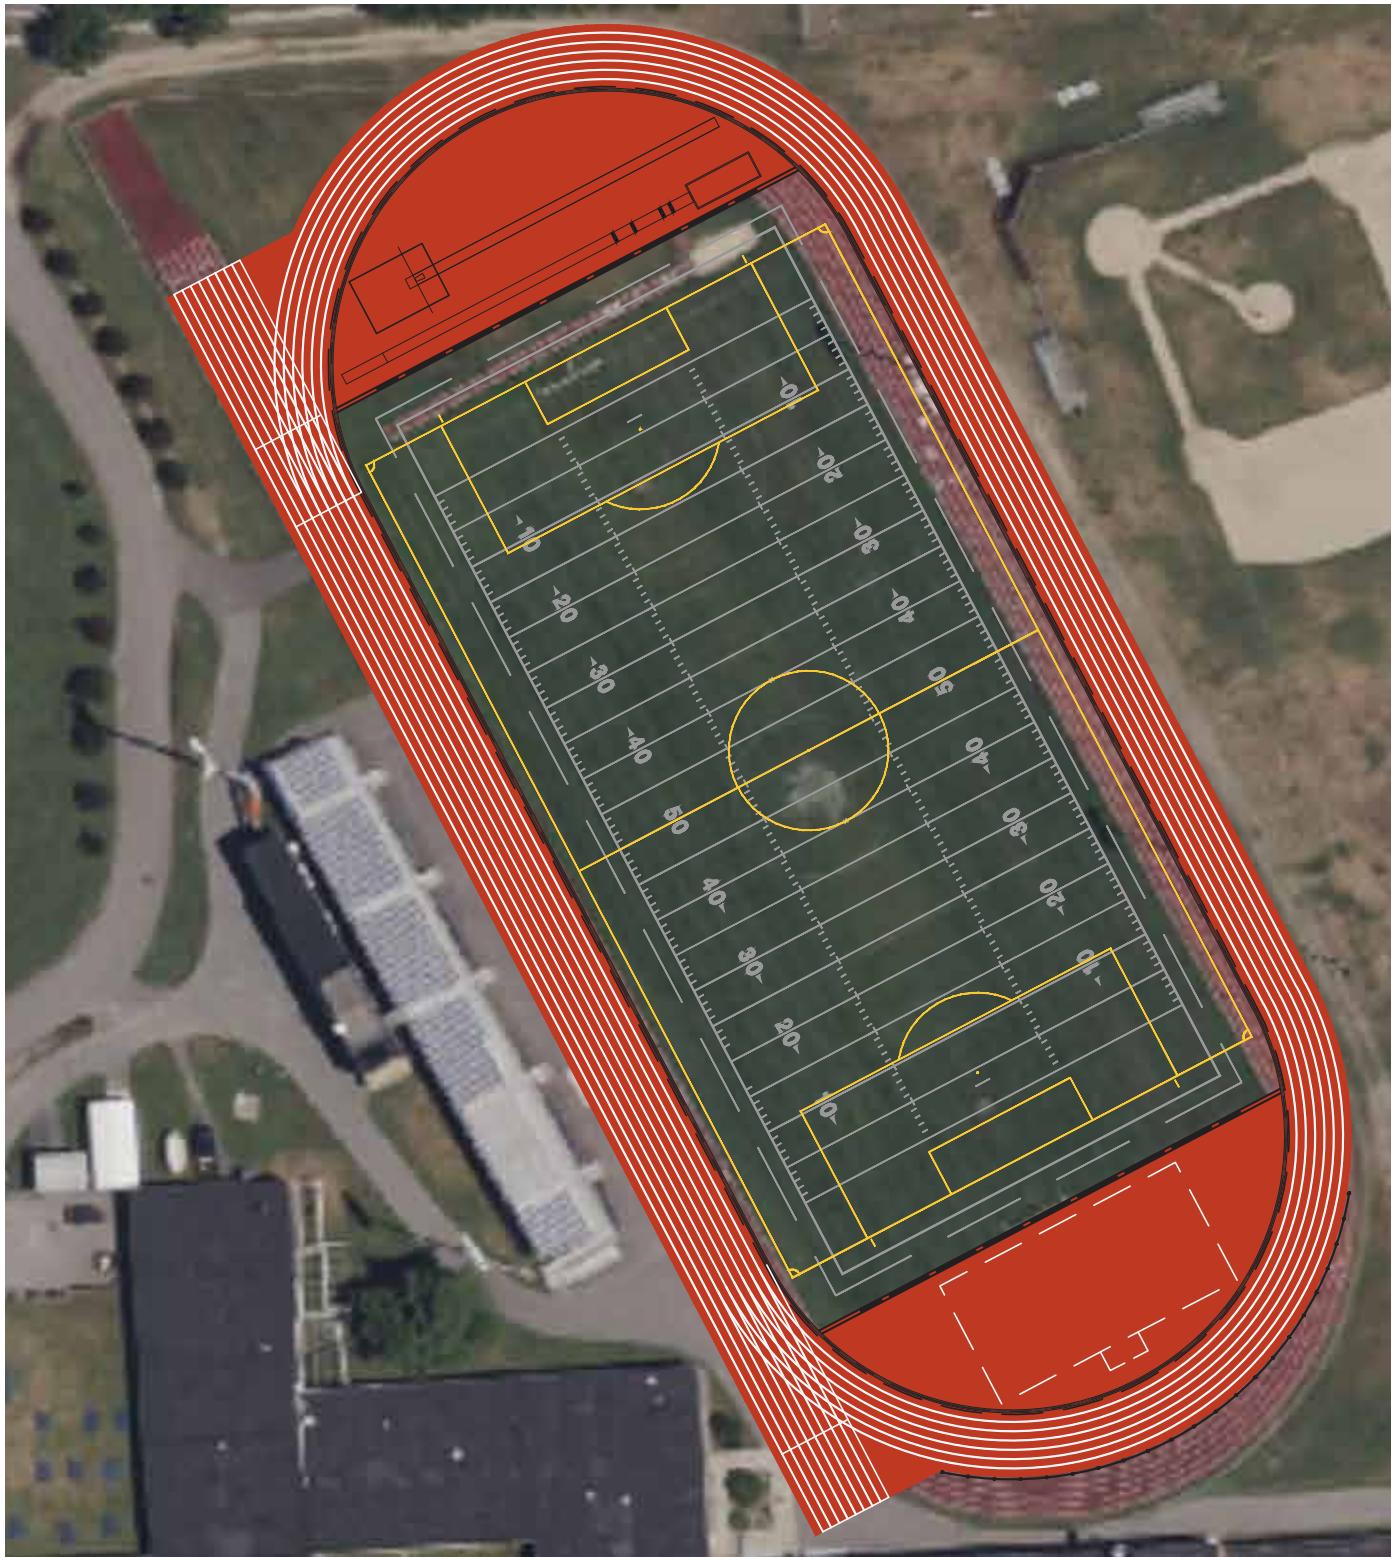
RECOMMENDED: SYNTHETIC TURF FIELD WITH EQUAL QUADRANT TRACK WITH 8-LANE STRAIGHT AWAY WITH 6 LANE TURN

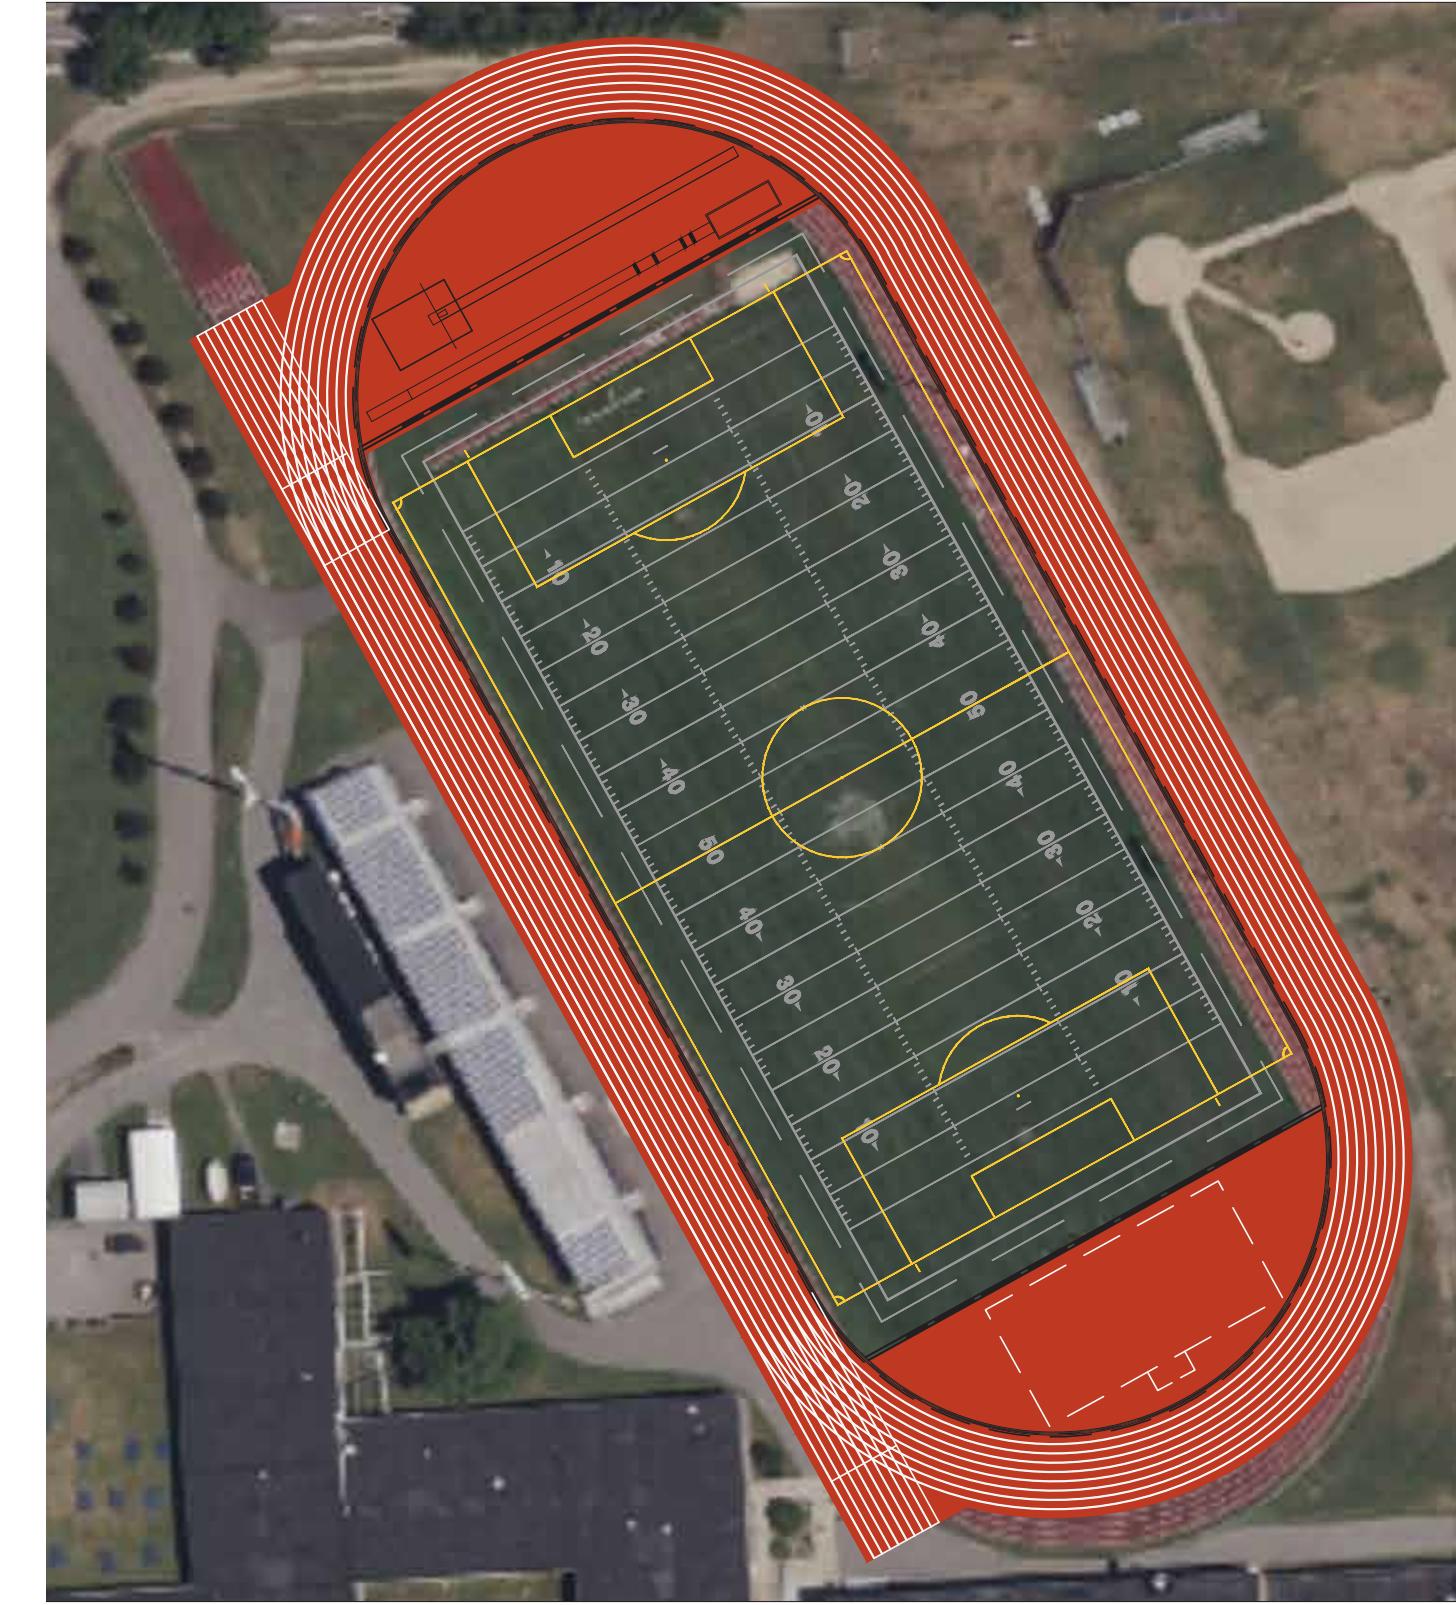
OPTION 4: SYNTHETIC TURF FIELD WITH EQUAL QUADRANT TRACK WITH 8-LANE STRAIGHT AWAY and TURN

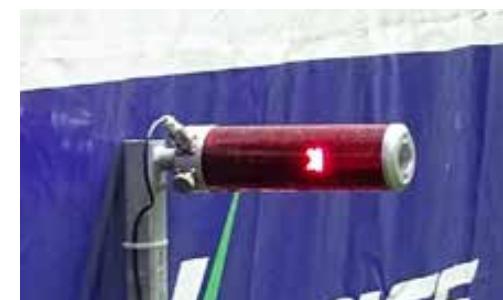
SISGRASS HYBRID PITCH CROSS-SECTION

- ▷ **SPEED** - SISGrass machines operate up to 3 times faster than other systems on the market.
- ▷ **ACCURACY** - Greater accuracy of installation thanks to the Laser-guided system.
- ▷ **ELECTRIC MACHINES** - our electric machines can reduce the carbon footprint of each pitch installation and reduce the risk of oil leaks
- ▷ **BESPOKE** - Stitch spacing can be tailored to customers' requirements and budget.
- ▷ **SAFE** - Flat tracks for minimal turf surface disturbance.
- ▷ **FIBRES** - Unique durable two tone fibres that meet the requirements of FIFA and World Rugby.
- ▷ **PATENTED** - Mechanism which allows the machine to insert the synthetic fibres efficiently and accurately.
- ▷ **MANY APPLICATIONS** - a system that is not only dedicated to football and rugby but can reinforce any natural grass playing surface.
